International Journal of Machine Tools and Manufacture

Research Paper

Mechanisms of tool-workpiece interaction in ultraprecision diamond turning of single-crystal SiC for curved microstructures

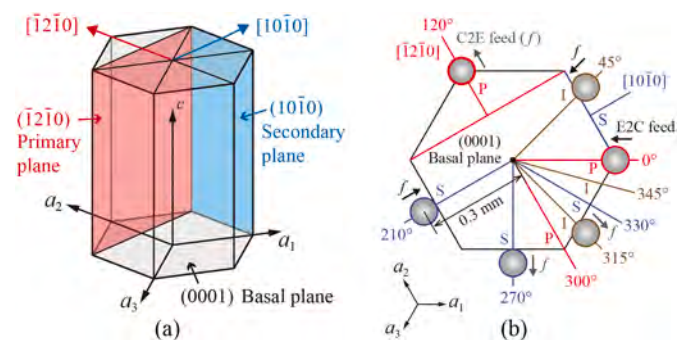
Fig. 1. Schematics of the planar orientation of the machined surface in 4H-SiC crystals: (a) hexagonal close packed lattice structure of 4H-SiC, (b) orientations of the dimples in the basal plane (C2E: centre-to-edge, and E2C: edge-to-centre).

with dimension $15 \times 10 \times 0.35$ mm was used as the workpiece. The surface roughness and flatness are 0.2 nm Sa and 0.9 nm, respectively, in a field of $250 \times 250 \mu\text{m}^2$. It is considered that 4H-SiC is the most difficult-to-cut compared to other types of SiC, such as 3C-SiC and 6H-SiC, but 4H-SiC can produce with the best subsurface integrity [32]. 4H-SiC has a hexagonal close packed lattice structure, as illustrated in Fig. 1a. On the basal plane (0001), the $\langle -12-10 \rangle$ and $\langle 10-10 \rangle$ directions are normal to the primary planes $\{-12-10\}$ and secondary planes $\{10-10\}$, respectively. For simplicity, the $\langle -12-10 \rangle$ and $\langle 10-10 \rangle$ directions are referred to as the “P” (primary) and “S” (secondary) directions, respectively, and the in-between directions are referred to as the “I” (intermediate) directions, as illustrated in Fig. 1b.

As the basal plane shows 60° symmetry, two dimples were machined at each angular position P, I, and S, and the directions of the tool feed were set to edge-to-centre (E2C) and centre-to-edge (C2E) as illustrated in Fig. 1b. Two kinds of dimples with curvature radius (R_d) of 2 and 3 mm were fabricated. The dimples were located 0.3 mm away from the workpiece rotation centre, and the dimple depth (D) was varied from 0.4 to 1.2 μm . The tool feed rates of 0.25 and 0.2 $\mu\text{m}/\text{rev}$ were used under a spindle rotation rate of 30 rpm. The conditions for turning micro spherical dimples on 4H-SiC are summarized in Table 1. After cutting, scanning electron microscopy (SEM), differential interference contrast (DIC) microscopy, white light interferometry, cross-sectional transmission electron microscopy (XTEM), and laser micro-Raman

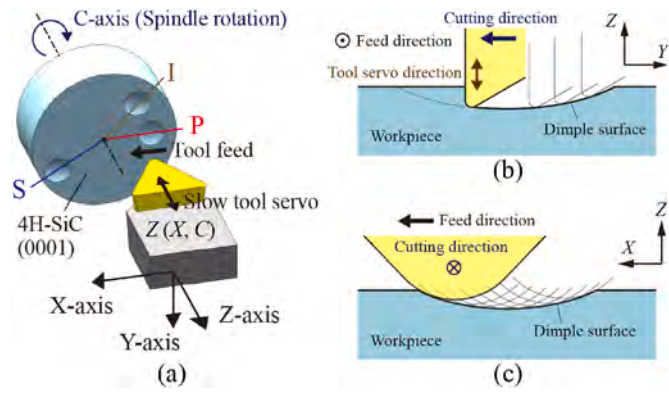
Fig. 2. Schematics of diamond turning spherical dimples with slow tool servo system: (a) configuration of the lathe, (b) a typical curved toolpath along cutting direction, and (c) dimple surface enveloped by multiple toolpaths in tool feed direction.

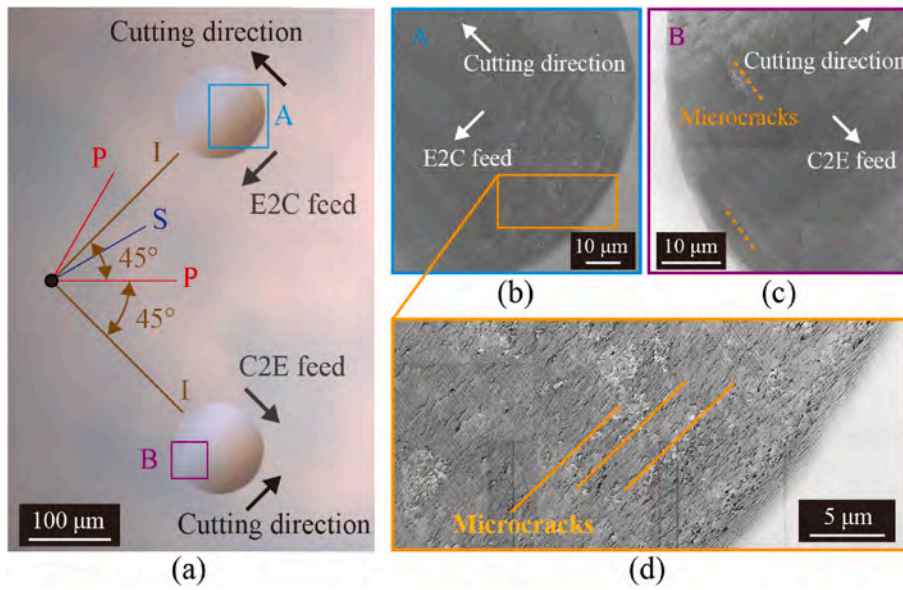
Fig. 4. (a) DIC microscopy image of I-dimples which are located at the angular positions in-between $\langle -12-10 \rangle$ and $\langle 10-10 \rangle$ directions; (b) and (c) are SEM images of the dimple machined under edge-to-centre (E2C) and centre-to-edge (C2E) feeds, respectively, whose observation zones are marked in (a) with blue and purple rectangles, respectively; (d) close-up view of the cut-in area in the dimple with E2C feed, which is outlined in (b) with orange rectangle (the orange lines marked in (d) indicate the directions of cracks). (For interpretation of the references to colour in this figure legend, the reader is referred to the Web version of this article.)

Fig. 4a illustrates the DIC microscopy image of the dimples located at the angular position I (I-dimples). Surface damage tends to occur at the location of the feed-in/cut-in areas, as indicated by A and B, which is similar to the damage distribution features in P-dimples. The SEM images of areas A and B (see Fig. 4b and c) indicate that similar to the cracks in P-dimples, the cracks formed perpendicularly to the cutting direction in I-dimples. However, as seen in the close-up view of the cut-in area with E2C feed (see Fig. 4d), numerous short and narrow cracks were generated, which are distinctly different from the cracks formed in the P-dimples.

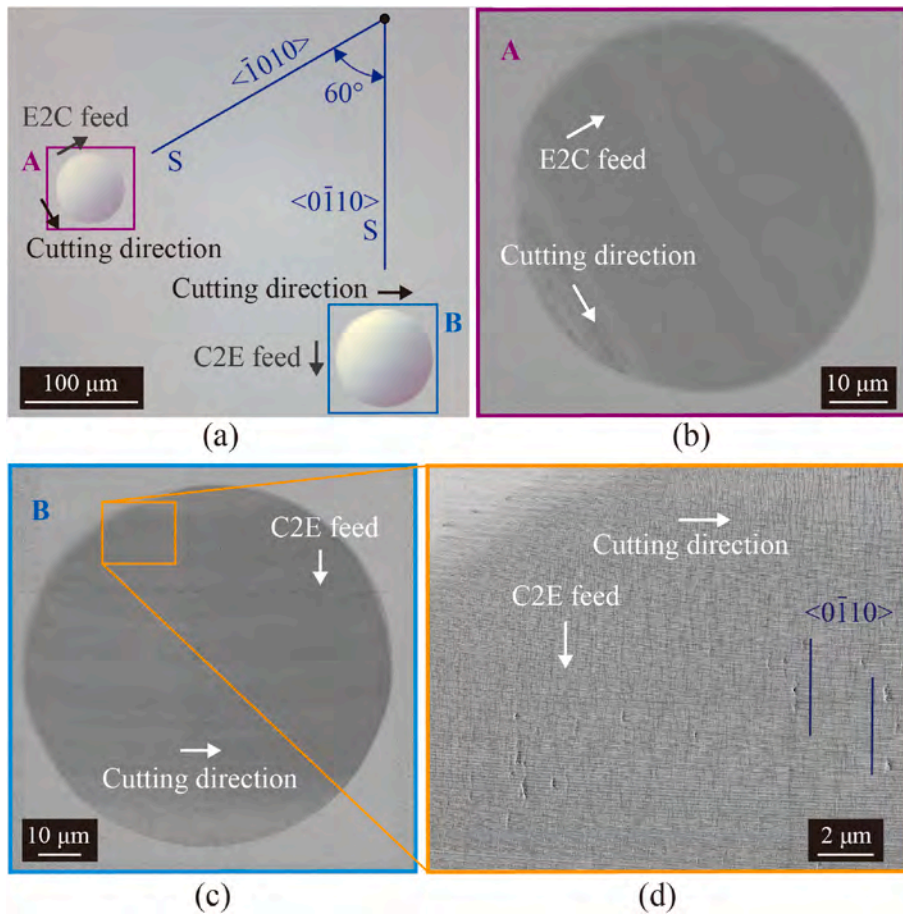
Fig. 5. (a) DIC microscopy image of S-dimples which are located at the angular positions in $\langle 10-10 \rangle$ directions; (b) and (c) are SEM images for the dimples machined under edge-to-centre (E2C) and centre-to-edge (C2E) feeds, respectively, whose observation zones are marked in (a) with purple and blue rectangles, respectively; (d) close-up view of the cut-in area in the dimple with C2E feed (The blue lines marked in (d) indicate the directions of cracks). (For interpretation of the references to colour in this figure legend, the reader is referred to the Web version of this article.)

Fig. 5a illustrates the DIC microscopy image of the dimples located at the angular position S (S-dimples). Unlike the P- and I-dimples, there are no evident damages on the S-dimple surfaces, even at the feed-in/cut-in areas. The SEM observation confirms that, for the shallower dimple (see Fig. 5b), the entire surface is crack-free, while for the deeper dimple, only several microcracks formed in the feed-in/cut-in area, as shown in Fig. 5c. These microcracks are perpendicular to the cutting direction, as displayed in Fig. 5d. However, these cracks are distinctly smaller and fewer compared to the cracks in the P- and I-dimples.

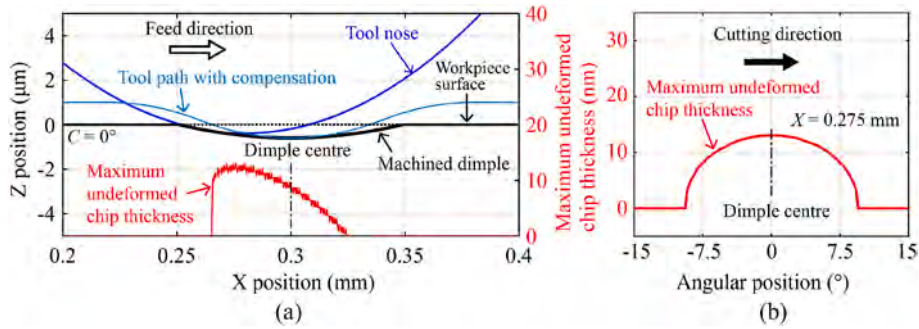
Fig. 16. Variation in maximum undeformed chip thickness: (a) along feed direction, and (b) along cutting direction.

Fig. 16a depicts the variation in h_m along the angular position $C = 0^\circ$ while a dimple with C2E feed is cut. The value of h_m suddenly increases from zero to a high value at the feed-in stage, and then increases to a maximum before the tool feeds to the centre of the dimple. Thereafter, the h_m gradually decreases to zero as the tool feeds out. The variation in h_m is asymmetrical in the direction of the tool feed, which is consistent with the trend of the cutting forces depicted in Fig. 12e. This implies that the large undeformed chip thickness in the feed-in area causes the high cutting forces.

In contrast, h_m is symmetrical with respect to the dimple centre in the cutting direction, as depicted in Fig. 16b. Therefore, F_c is also symmetric, as proven by the experimental result presented in Fig. 12f. However, at the cut-in stage, the tool not only moves forward but also indents into the workpiece, similar to the loading process of indentation. In contrast, the tool withdraws from the workpiece at the cut-out stage, similar to the unloading process of indentation. Therefore, for the same
